Test results of electro-polishing for quarter-wave resonators

OK.Nii, Y.Ida, H.Ueda, T.Yamaguchi (Marui Galvanizing Co., Ltd.)
H.Kabumoto, J.Kamiya, Y.Kondo, J.Tamura, H.Harada, Y.Matsui, M.Matsuda
(Japan Atomic Energy Agency (JAEA))

TTC 2022 meeting
WG2
11-14 October 2022

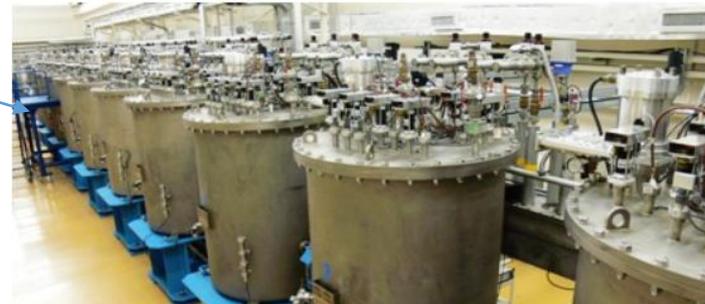
Superconducting booster

At the Tokai Tandem Accelerator of JAEA, research on nuclear physics, nuclear chemistry, material irradiation, etc. using heavy ion beams is being conducted. A superconducting booster has been installed in the latter part of the tandem to increase the beam energy by 2 to 3 times, but it has been out of service for a long time. The specifications of this superconducting booster are model = coaxial 1/4 wavelength resonator (QWR), frequency is 130MHz, optimum beam velocity = 10% of the light velocity, and acceleration electric field = 5.0MV / m @ 4W.

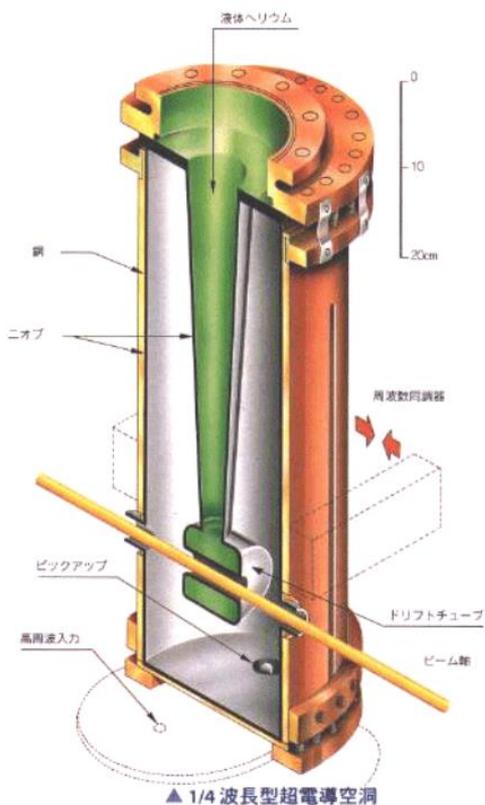
Quarter wave resonators
(Outside : copper
Inside : Niobium)

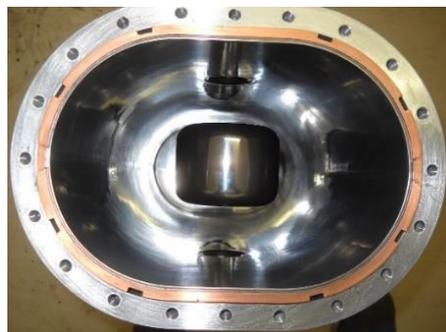
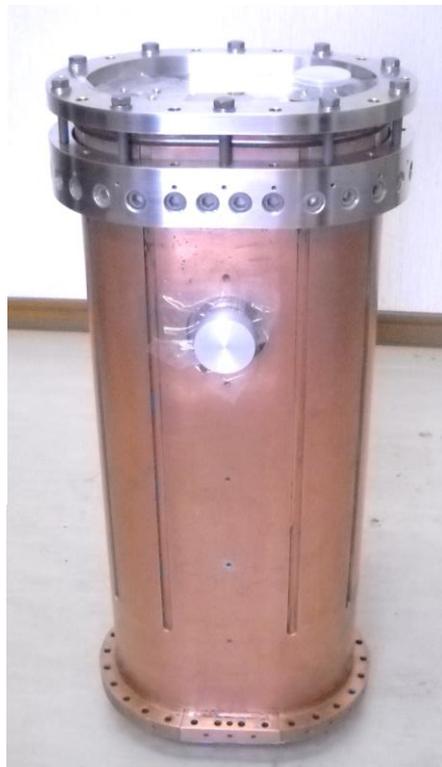
A spare cavity used for experiments (L42)

Currently, we are working on restarting, and we are considering electro-polishing of the preliminary superconducting cavity in preparation for conducting various tests. This cavity is made of a niobium-copper clad plate and has a large opening at the bottom, which allows it to be electro-polished again.

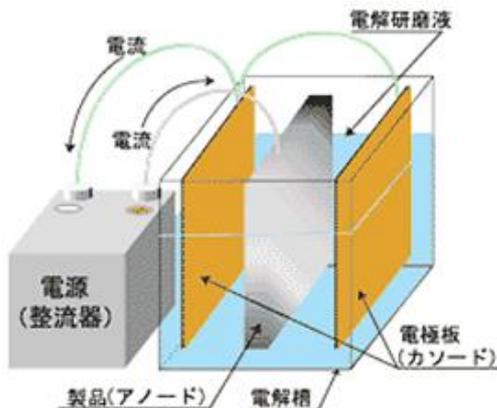
General method of EP (schematics)

A technology that dissolves and polishes the metal surface by electrolyzing the object (metal to be polished) as the anode in an electrolytic solution with a counter electrode (cathode).

Improves surface flatness, corrosion resistance, and cleanliness.

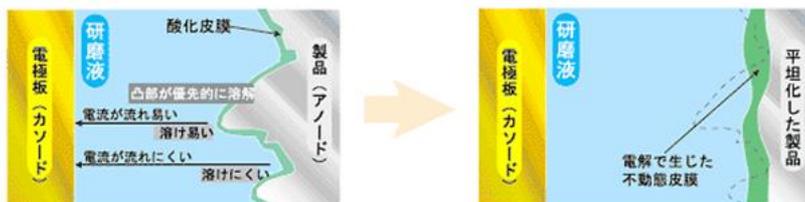
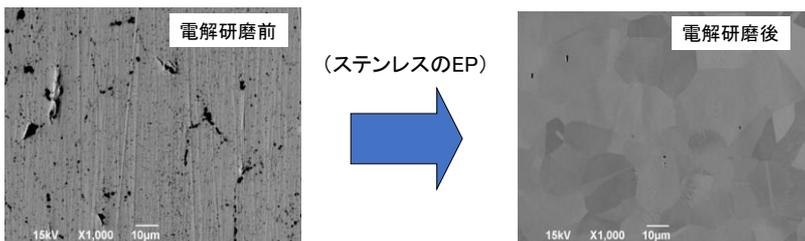
How EP progresses (schematics)

Since the protruding part of the product is close to the cathode, electricity flows easily and it melts easily. Since the amount of melting is proportional to the amount of electricity, the convex portion melts preferentially. As a result, the unevenness gradually disappears and the surface becomes flat.

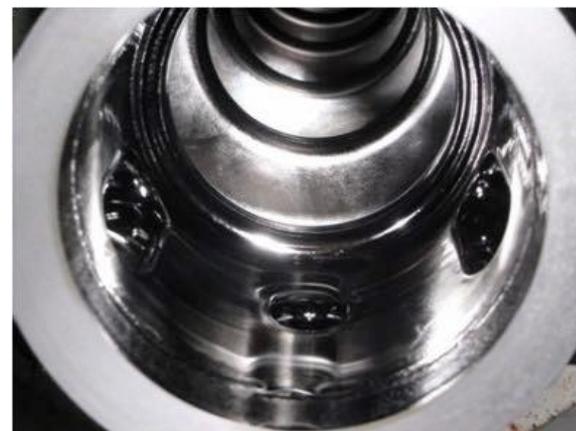
Niobium cavity EP

In 1.3GHz niobium superconducting cavities, electro-polishing is applied to the inner surface to improve cavity performance.

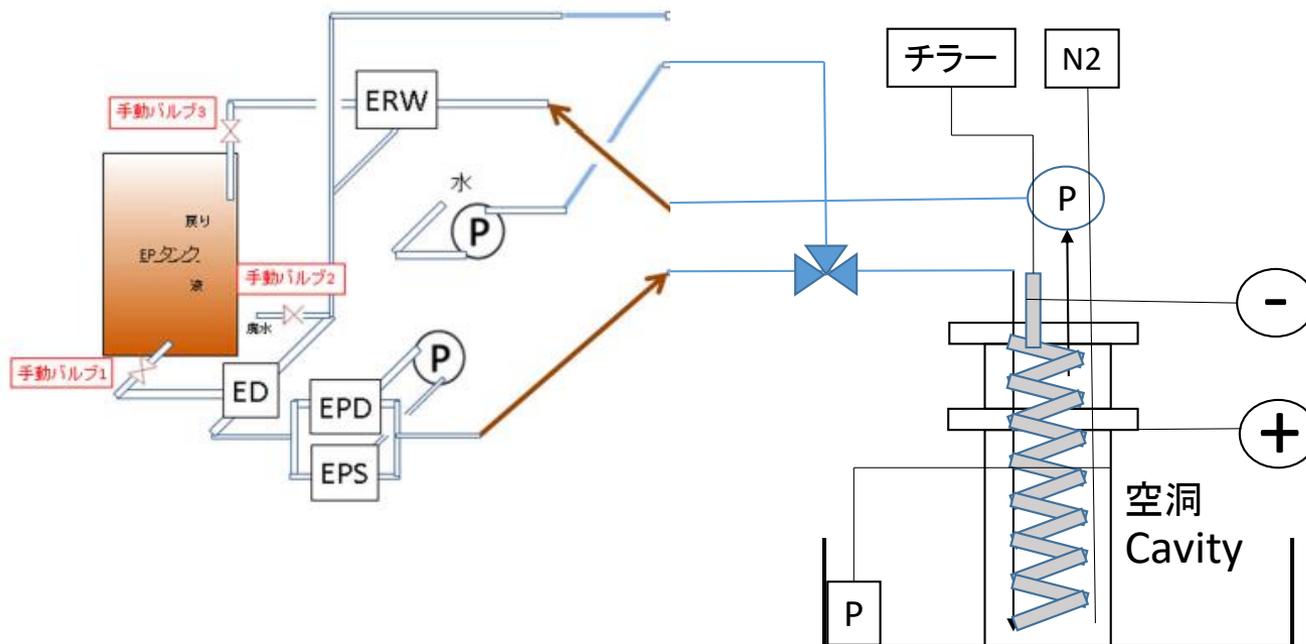
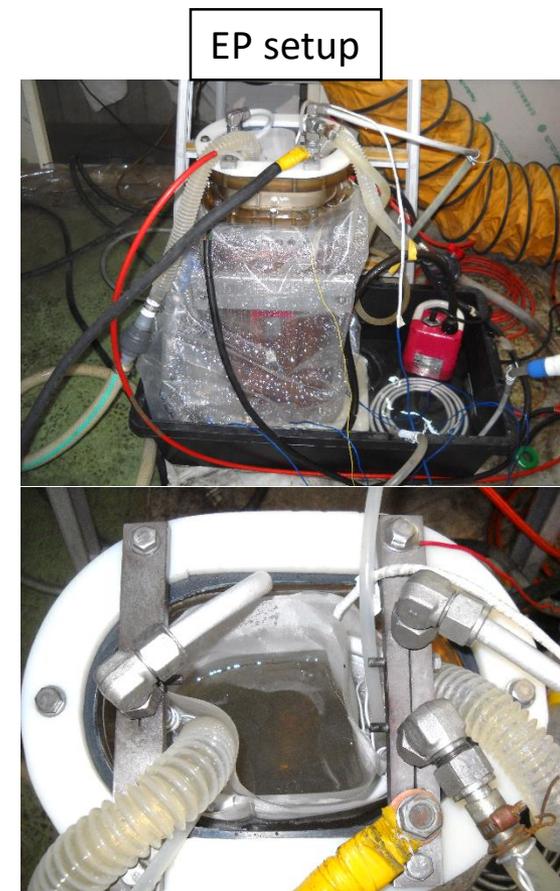
A schematic of EP setup

- Place the cavity with the opening facing up. Electrodes and electrolyte hoses were inserted through the openings.
- The electrolyte was circulated by a pump.
(Injected into the bottom of the cavity, recovered from the top)
- Cavity cooling by cooling water shower using vat and submersible pump
- There were no serious problems with the EP implementation.

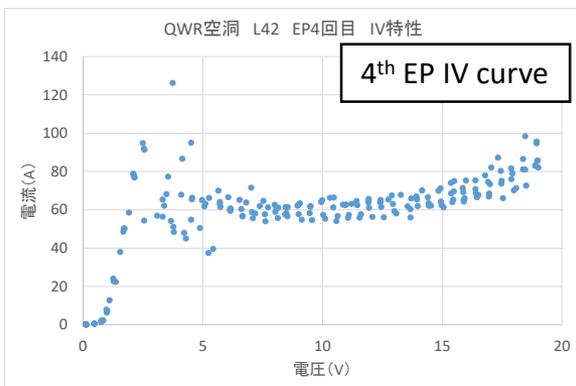
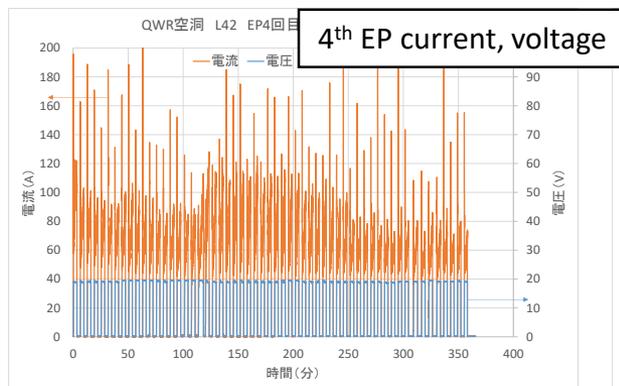
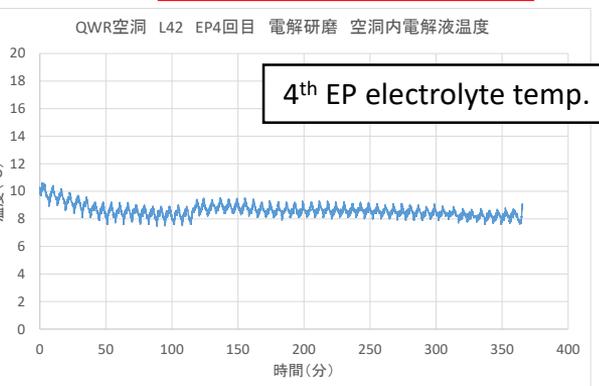
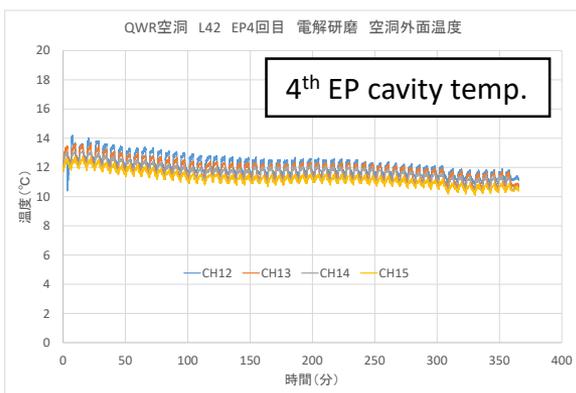
- 4 times EP (total removal 100μm) were performed using one cavity (L42).
 - The logged data of 4th EP is shown.
 - In IV curve, plateau region was shown around >5V.
 - Cavity temperature was around 10-14°C using water cooling.
 - Electrolyte temperature in the cavity was under 10 °C .
 - EP current was around 80 A.
- EP current, voltage, temperature were almost on target.

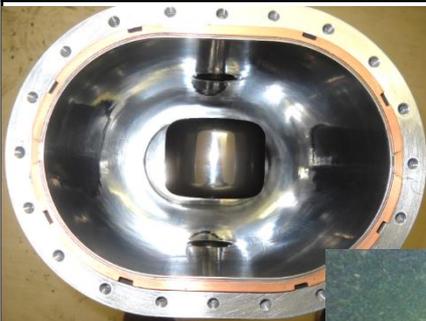
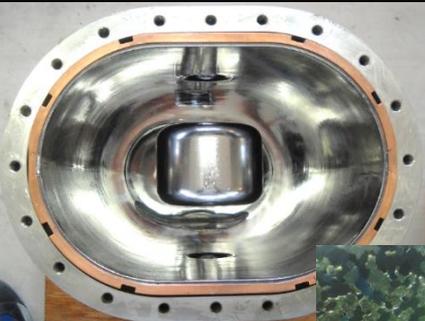
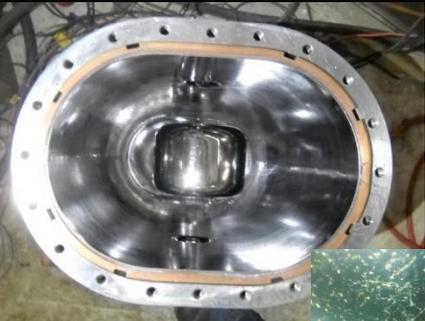
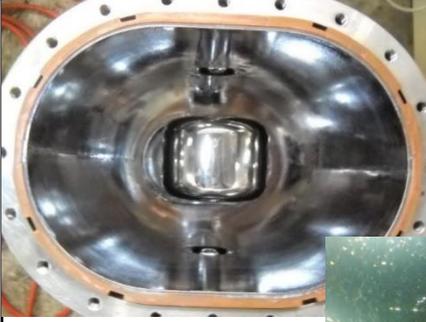
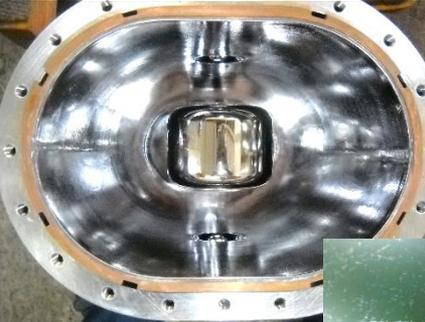
2-2 Results of EP (surface inspection and roughness)

| Before EP (Mechanical polish) | After 1 st EP | After 2 nd EP |
|---|--|---|
| <p data-bbox="106 556 347 656">Ra = 0.11μm Rz = 1.21μm</p> | <p data-bbox="705 556 946 656">Ra = 0.67μm Rz = 3.40μm</p> | <p data-bbox="1313 556 1555 656">Ra = 0.48μm Rz = 2.53μm</p> |
| <p data-bbox="106 1092 347 1192">Ra = 0.47μm Rz = 2.24μm</p> | <p data-bbox="705 1092 946 1192">Ra = 0.45μm Rz = 2.06μm</p> | <div data-bbox="1304 863 1632 906" style="border: 1px solid black; padding: 5px;">Digital camera photo</div> <div data-bbox="1603 1042 1796 1170" style="border: 1px solid black; padding: 5px;">Microscope photo (× 200)</div> <div data-bbox="1275 1106 1564 1185" style="border: 1px solid black; padding: 5px;">Surface roughness (Average of 4 points)</div> |

- After 1st EP, the surface roughness became worse (It seems that the conditions were not optimized).
- After 2nd – 4th EP, the surface roughness tended to improve (The conditions seem to have improved).
- After 4th EP, the surface became more glossy but roughness was larger than before EP.

- Compared to before electro-polishing (surface after mechanical polishing), the surface gloss seemed to be improved, but the surface roughness value became worse.

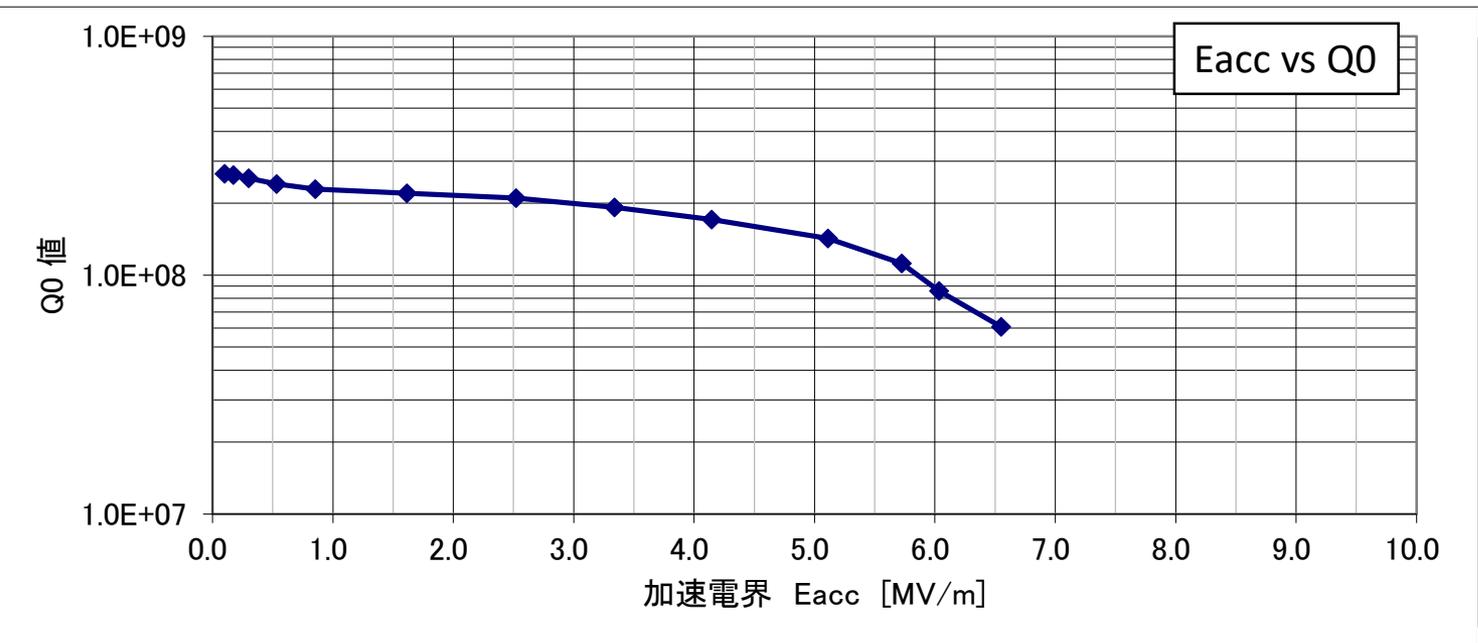
Measurement of the cavity performance

After Phase 1 EP, the cavity performance was measured at 4.2K.

Low electric field Q_0 value was $2.7E8$ and the cavity performance was $4.2MV/m @4W$

It did not reach the standard value ($5.0MV/m @4W$)

The main reason seems to be rough surface and high surface resistance.

- As a result of the cavity performance measurement in liquid helium (4.2K), the performance was 4.2MV/m@4W with a Q0 value of 2.7E8 at a low electric field. This did not reach the standard value (5.0MV/m@4W).

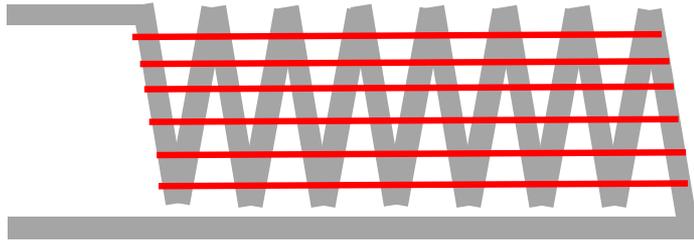
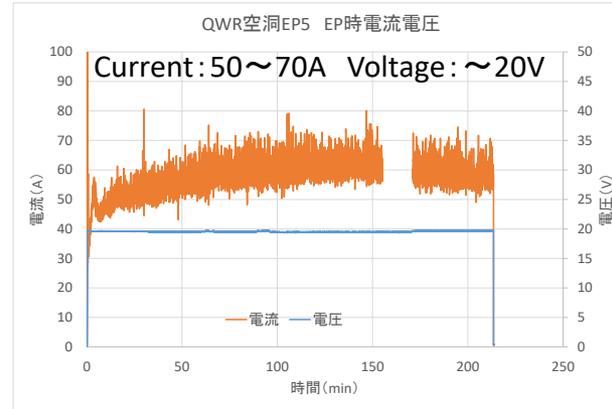
A schematic of electrode, auxiliary electrode

- An auxiliary electrode was added to the conventional electrode in order to increase the current density and improve the polished surface by increasing the cathode area. (Approx. 30% increase in electrode area, red line in the above schematic)
- No clear improvement was seen (details later).
→ There is no problem with the conventional electrode.

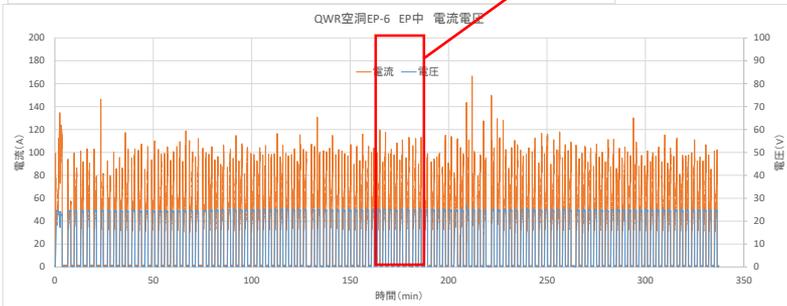
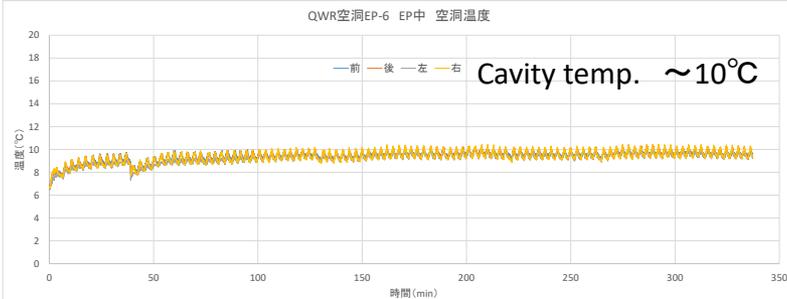
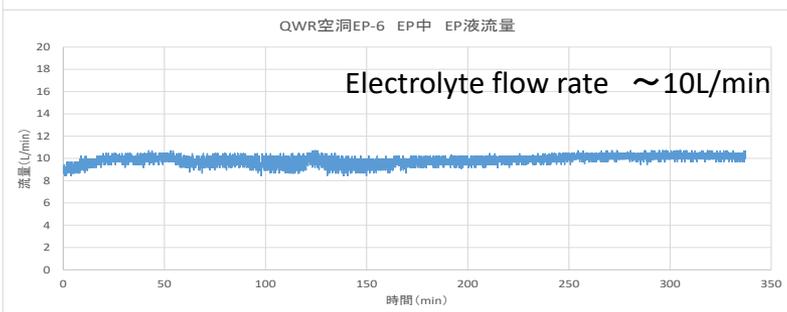
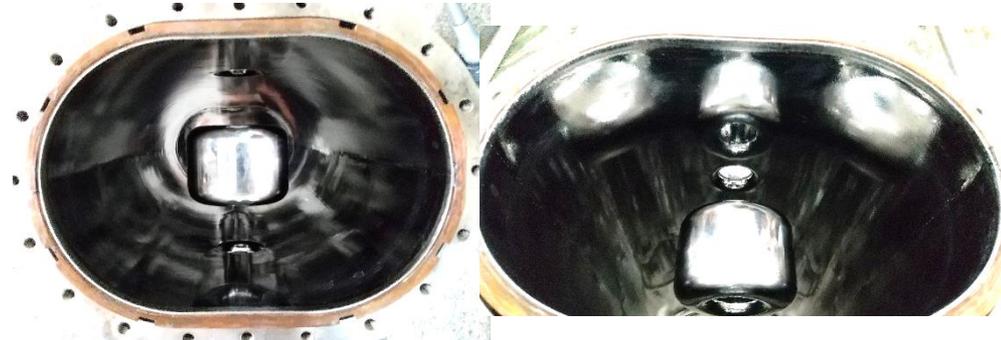
Current : 40~100A
Voltage : ~25V
1min-ON/1min-OFF

- To confirm the range of the plateau region, the IV characteristics were confirmed from 0 to 30V.
- An increase in current was observed from 25V in the IV curve.
- 5~25 V is set as the plateau region from the shape of the curve and EP was performed at 25V that is the upper limit of the plateau.
- No clear improvement was seen (details later).
- There is no problem with the conventional 20V.

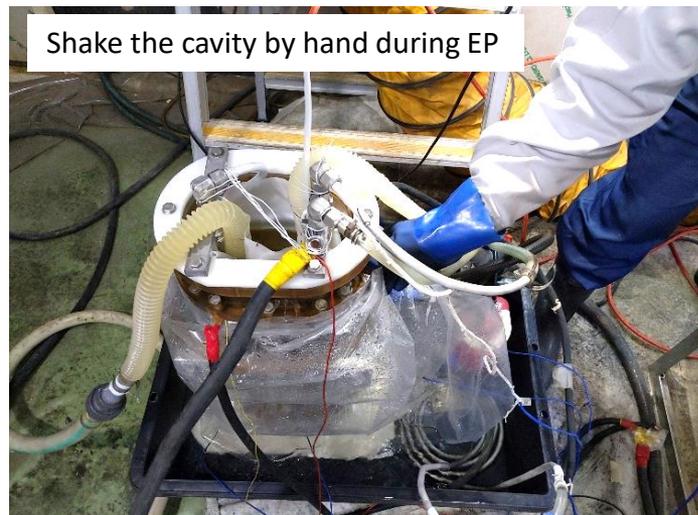
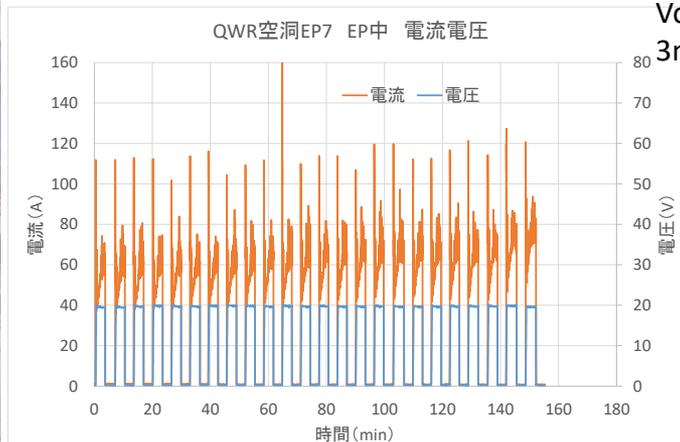
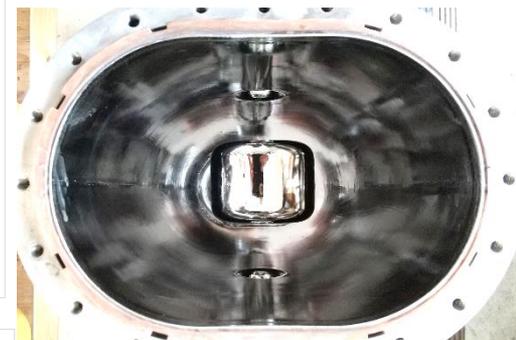
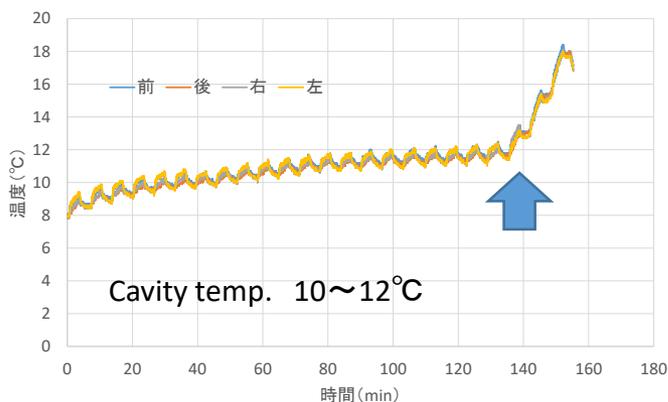
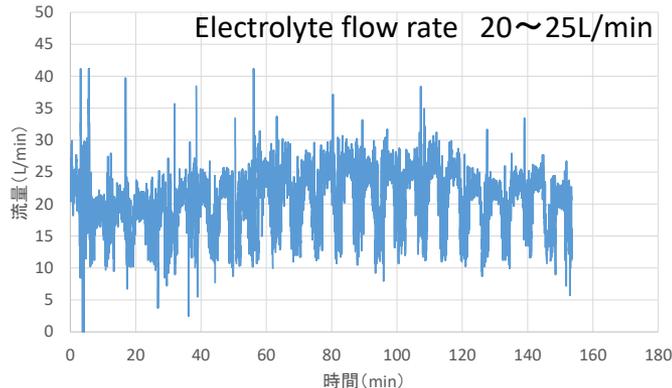
Current: 40~80A
Voltage: ~20V
3min-ON/3min-OFF

Shake the cavity by hand during EP

- Electrolyte flow rate was increased to ~20L/min and it was shaken by shaking the cavity by hand to improve agitating effect during EP.
- EP was stopped due to temperature and odor abnormalities during EP. The cause was that the center conductor had a hole and the electrolyte was leaking into the cavity cooling water.

- The removal thickness of the center conductor was much larger than other parts, and a hole was opened during the Phase 2 experiment. No significant improvement in surface roughness was observed.

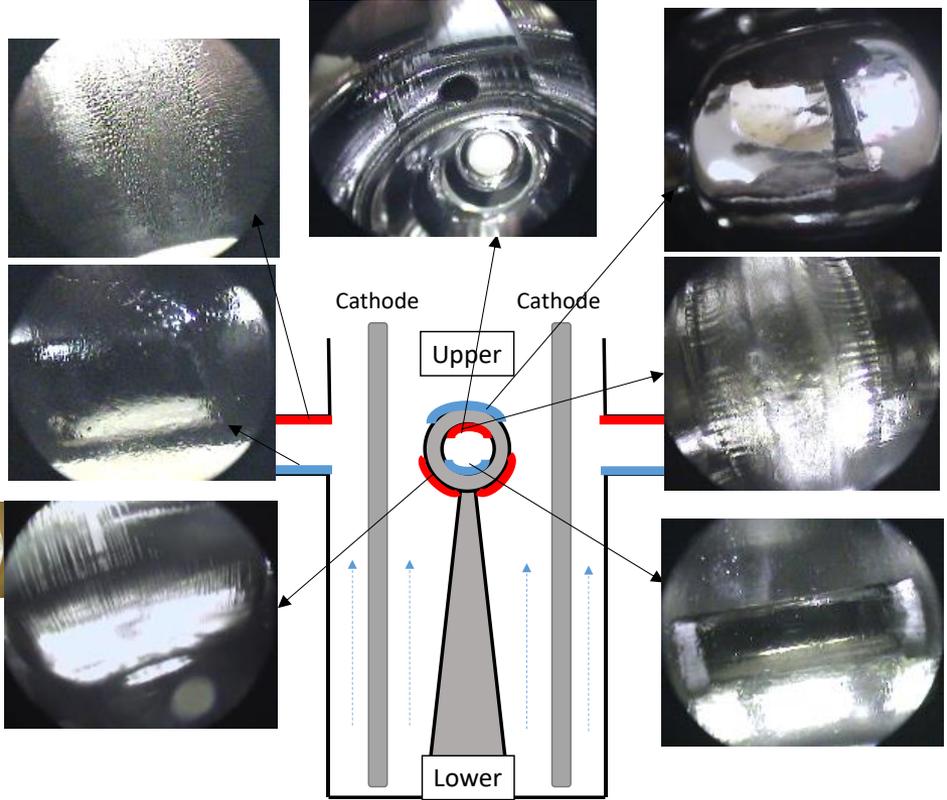
Measurement points

Results of removal and roughness evaluation

- The removal thickness of center conductor is 2-3 times larger than that of body part.
- The surface roughness has no proper tendency and has not changed significantly in case of phase 2 EP.
